Industrial Paste-Grade Lining for Protection Against Abrasive Attack

Belzona 1812 (Ceramic Carbide FP) is a two-component repair and protective coating for the protection of surfaces subject to abrasive attack.

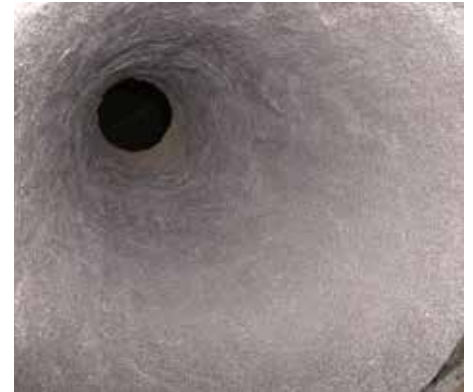
Steel cone coated in Belzona 1812
